ASBESTOS CEMENT PIPE (TRANSITE)

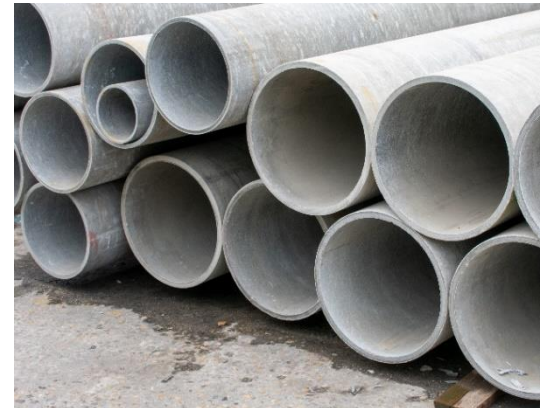
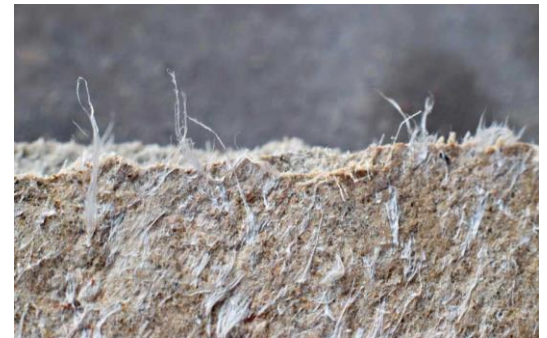
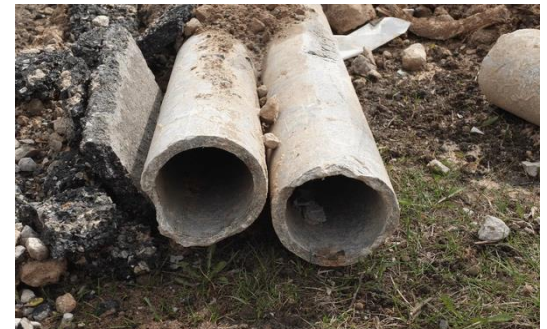
- White-gray or tan-beige color;
- Cementitious composition;
- Hollow-sounding or little to no reverberation when knocked;
- Presence of white, gray, or sometimes blue-green fibers when closely examined or at damaged ends; and
- Most lines feature spigot-and-socket or rigid sleeve couplings, and some may have molded fittings.
